REAL BIG POWER PARTNERS

Sherwin Alumina
Falls Work, OH

Sample ID: GPP-0370349302-BFP-1B
Equip. Desc.: BFP-1B Sulzer Pump
Lubricant Type: Chevron AW-46
Reservoir Cap.: 70.00 Gal(s) 264.95 Ltr(s)
Machine Time: 21,457.3 Hr(s)
Lube Time: 1,587.6 Hr(s)

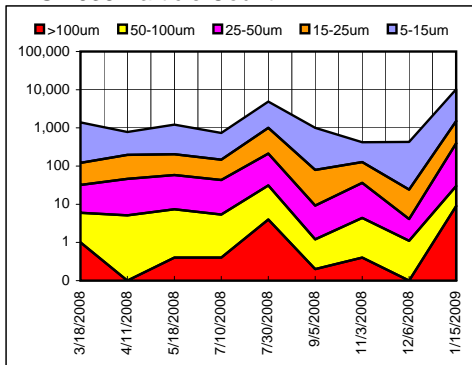
NAS-1638 Particle Count

Particle Data		Lube Data	
5-15 µm	8,753	40°C cSt:	38.1
15-25 µm	1,112	Water-IR	1,245
25-50 µm	362	PLP	70.7%
50-100 µm	21		
>100 µm	9		
EPC:	10,257		
ISO Scale:	20 18

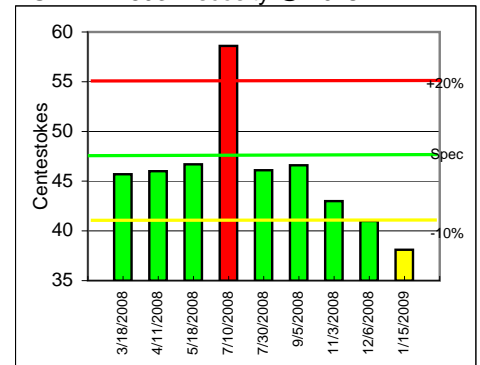
ASTM-D-2893 Viscosity @ 40°C

The viscosity of this sample is more than 10% lower than specification. This low viscosity has been confirmed Kinematically.

Consider scheduling this pump for maintenance action in the near future. Specifically, an alignment problem, where pump impeller wearing against pump housing. Locate and reduce the source of water contamination. CHANGE OIL to remove large metal debris, water contamination and correct low viscosity. Then RESAMPLE equipment to verify the generation of alignment wear particles.

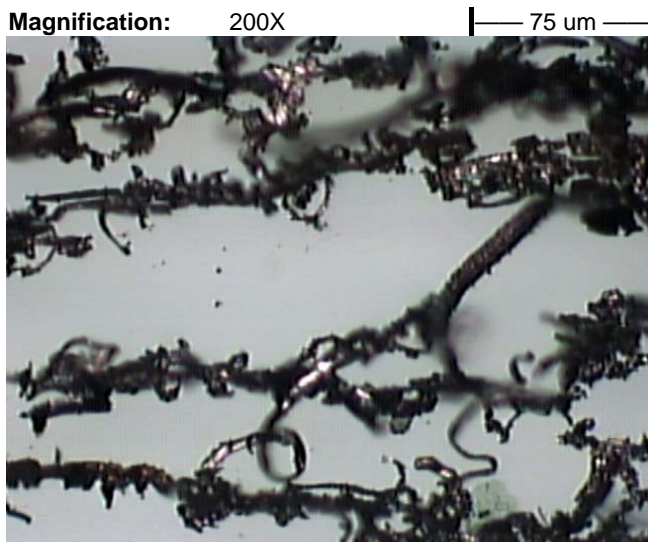
Image 1

The equipment particle concentration (EPC) has increased significantly for this equipment 429 to 10,257. Analytical results show the appearance of excessive concentration of 140 micrometer (µm) white non-ferrous metal Cutting/Plowing wear particles. Heat treatment of these large Cutting/Plowing wear particles show then to be composed of Aluminum alloy. However, Nickel, Chrome and Stainless steel are also possibilities. The high concentration of these particles and combination of near absent outside contaminants indicate this is an alignment problems. Analysis also shows a high concentration of Black Metal Oxides (Fe₃O₄). Black Metal Oxides typically form as the result of either improper or inadequate lubrication during the formation of the particles.

Shown in this image are examples 140um white non-ferrous metal Cutting/Plowing wear particles seen in this equipment. Note that this image was taken under low magnification to show the extent of the alignment problem.

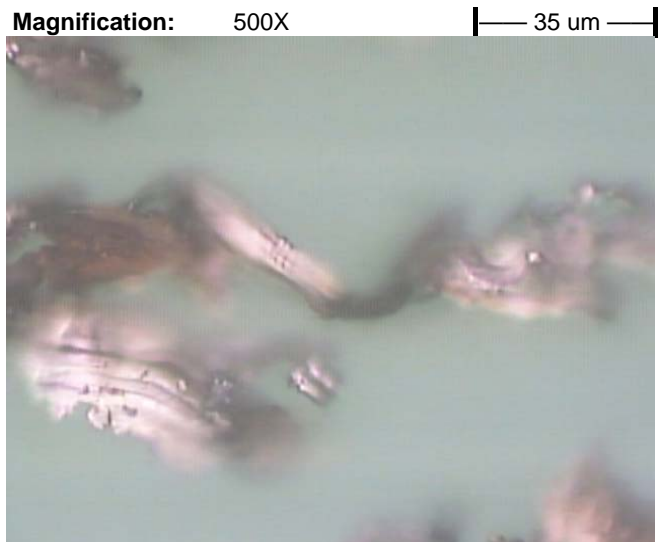
Image 2

This image displays examples of the excessively large Cutting/Plowing wear particles seen in this equipment.
