REAL BIG POWER PARTNERS

Sherwin Alumina
Falls Work, OH

Sample ID: GPP-0370349302-BFP-1B
Equip. Desc.: BFP-1B Sulzer Pump
Lubricant Type: Chevron AW-46
Reservoir Cap.: 70.00 Gal(s) 264.95 Ltr(s)
Machine Time: 21,457.3 Hr(s)
Lube Time: 1,587.6 Hr(s)

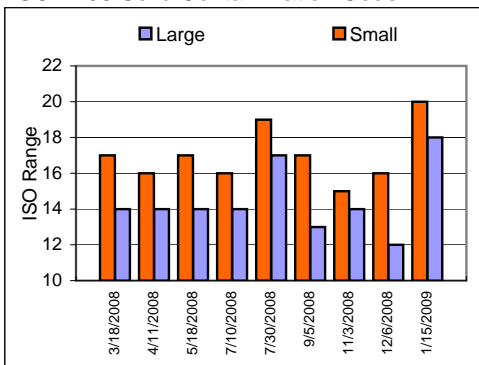
ISO-4406 Solid Contamination Code

The equipment particle concentration (EPC) has increased significantly for this equipment 429 to 10,257. Analytical results show the appearance of excessive concentration of 140 micrometer (µm) white non-ferrous metal Cutting/Plowing wear particles. Heat treatment of these large Cutting/Plowing wear particles show then to be composed of Aluminum alloy. However, Nickel, Chrome and Stainless steel are also possibilities. The high concentration of these particles and combination of near absent outside contaminants indicate this is an alignment problems. Analysis also shows a high concentration of Black Metal Oxides (Fe₃O₄). Black Metal Oxides typically form as the result of either improper or inadequate lubrication during the formation of the particles.

Consider scheduling this pump for maintenance action in the near future. Specifically, an alignment problem, where pump impeller wearing against pump housing. Locate and reduce the source of water contamination. CHANGE OIL to remove large metal debris, water contamination and correct low viscosity. Then RESAMPLE equipment to verify the generation of alignment wear particles.
